POPPLINGTON HISTORIC STUDY

B-2412
MAG#04124125604

<u>Block</u>	<u>Lot</u>	<u>Address</u>
154	5-1	321-329 N. Carey Street

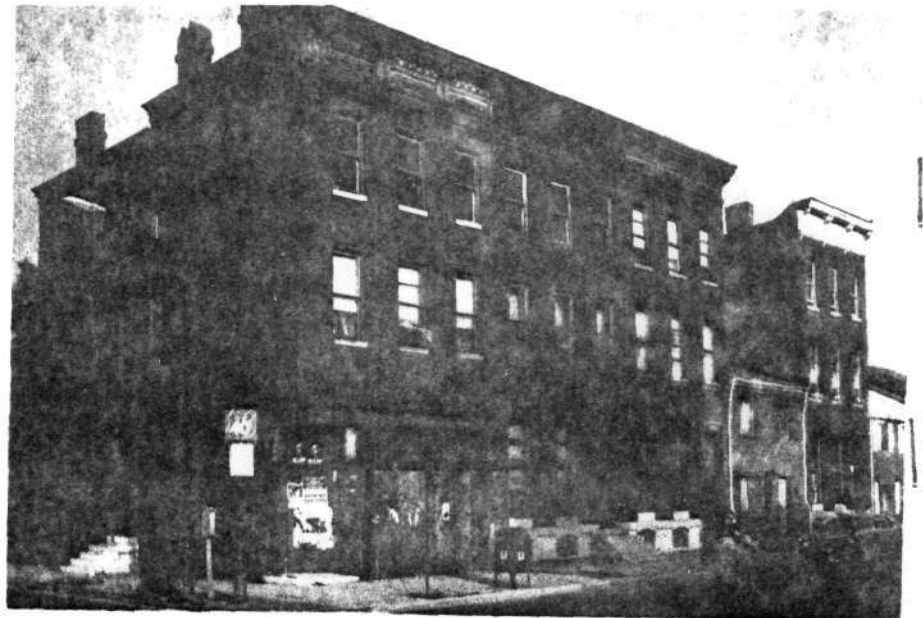
Notable features: The old houses are large, 3-window, elegantly detailed, with stone basement dressings and tall, to-floor first floor windows. Many still have original doors (see detail of number 327) and door surround. None of this kind of detail should be lost in rehabilitation if it can possibly be saved.

Number 329 has an entrance on Mulberry Street, an original store front, now vacant, facing Carey. The store may in future be feasible again because Carey Street will be open across the expressway in late 1976 or 1977.

Discussion of the new houses (see number 323) is reserved for the sheet on 301-319 N. Carey Street.

Environmental context: No vacancies or gaps (unless you could call the new houses gaps as one like number 323 appears to be). Carey is a wide, two-way street with not too much traffic. It is a pleasant street but could use street trees such as the ones in the block below Saratoga. The house-to-house scale has been damaged by the infills, which appear a bit pigmy-like. All seem to be well maintained, however.
